# RENEWING QM2

## A look at the work done during Queen Mary 2's 2008 Refit

On October 23, 2008, Queen Mary 2 entered drydock Elbe 17 at the Blohm + Voss Repair facilities in Hamburg, Germany for a refit. The drydocking lasted until November 13, 2008, during which time a massive amount of work was done on the ship.

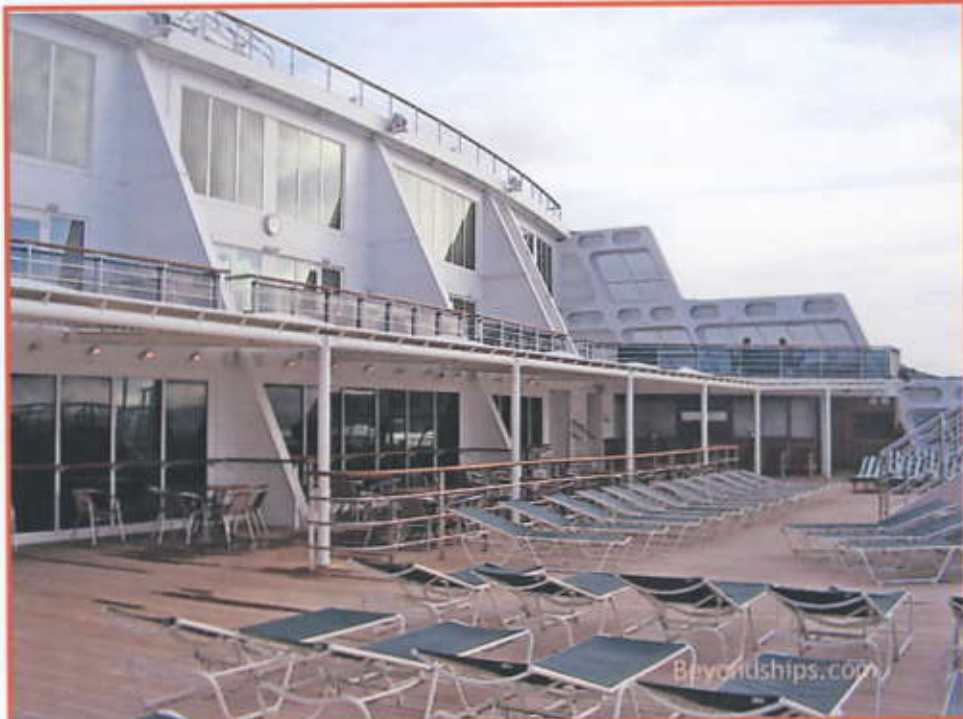
*Above: An awning was added to the Deck 8 Terrace that will enable the Todd English Restaurant to offer al fresco dining.*

Outdoors the most apparent change is the addition of an awning at the forward end of the Eight Deck terrace. The awning will allow the Todd English Restaurant to offer al fresco dining.

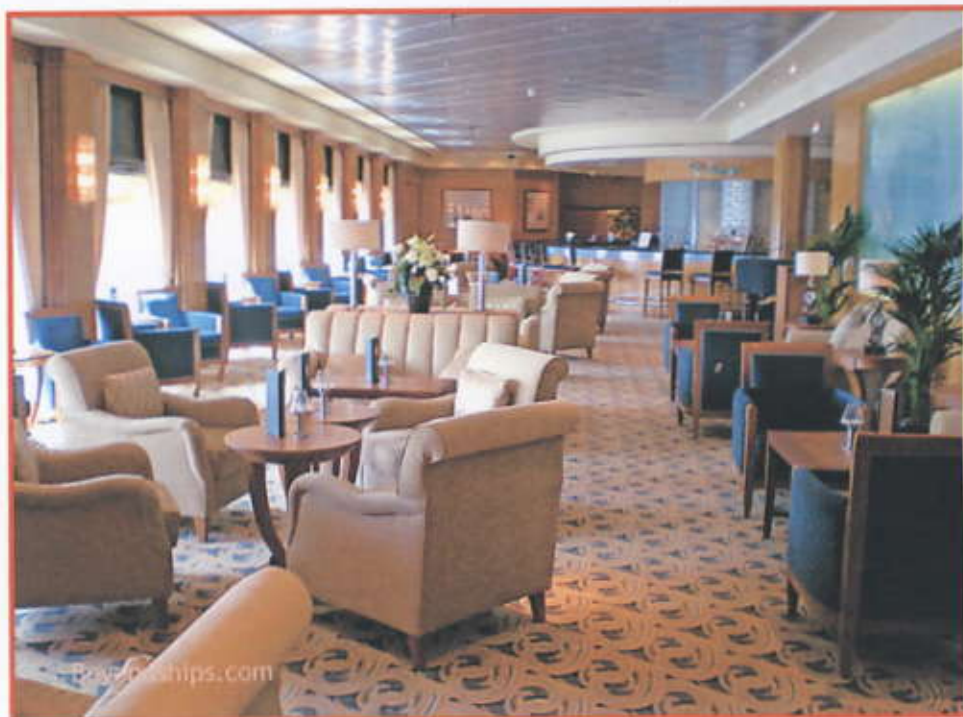
*Below: The Chat Room was extensively refurbished.*

**T**he most noticeable change to the interior public spaces is the refurbishment of the Chart Room bar. The room has a new color scheme reflected in new carpet, drapes and furniture. The room also has a new layout. As it was, the room had a wide expanse running down the middle between the tables that lined the windows and the tables that were next to the opposite wall. Under the new arrangement, the room no longer has this corridor-like look.
